# Manhole Inspection Summary

Manhole # S11KK\_001MH

**Location** Address: **2100 N ROSEDALE ST** Cross Street: **WINDSOR AVE**

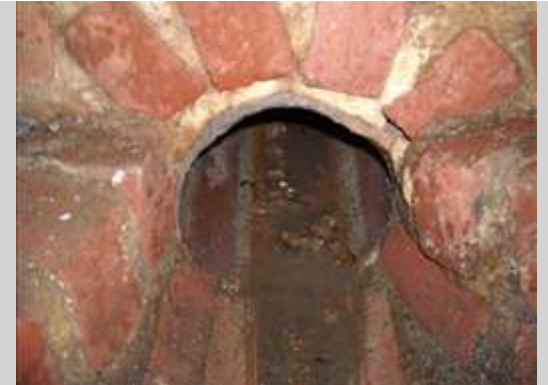
12 O'Clock Outflow

Pipe Height: **8.4** (in.) Rod and Bar (Angled)  
Pipe Material: **Clay** ☐ Pipe Lined  
Invert Depth: **7.01** (ft.) Flow Characteristics: **Slow**  
Deposits: ☒ None ☐ Mud ☐ ~~Gravy~~ ☐ Debris ☐ Grease  
Silt Depth: (in.) Deposits Extent:  
Infiltration: **None** Pipe Seal Cond: **Sound**

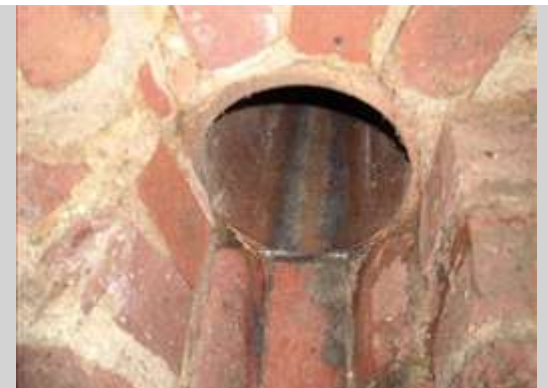
3 O'Clock Inflow

Pipe Height: **6** (in.) Rod and Bar (Angled)  
Pipe Material: **Clay** ☐ Pipe Lined  
Invert Depth: **6.30** (ft.) Flow Characteristics: **None**  
Deposits: ☒ None ☐ Mud ☐ ~~Gravy~~ ☐ Debris ☐ Grease  
Silt Depth: (in.) Deposits Extent:  
Infiltration: **None** Pipe Seal Cond: **Sound**

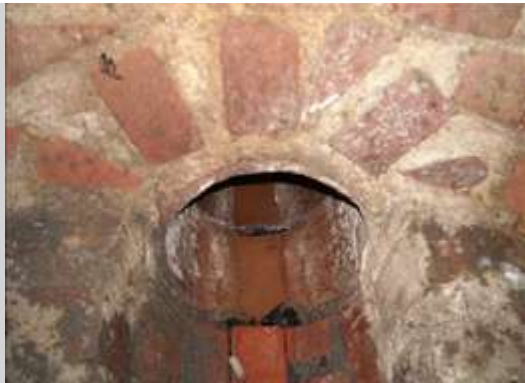
9 O'Clock Inflow

Pipe Height: **8.4** (in.) Rod and Bar (Angled)

Infiltration: **None** Pipe Seal Cond: **Sound**
